BUREAU OF SHIPS GROUP
TECHNICAL INSPECTION REPORT

⑥ OPERATION CROSSROADS,
U.S.S. NEW YORK (BB34).

TEST BAKER

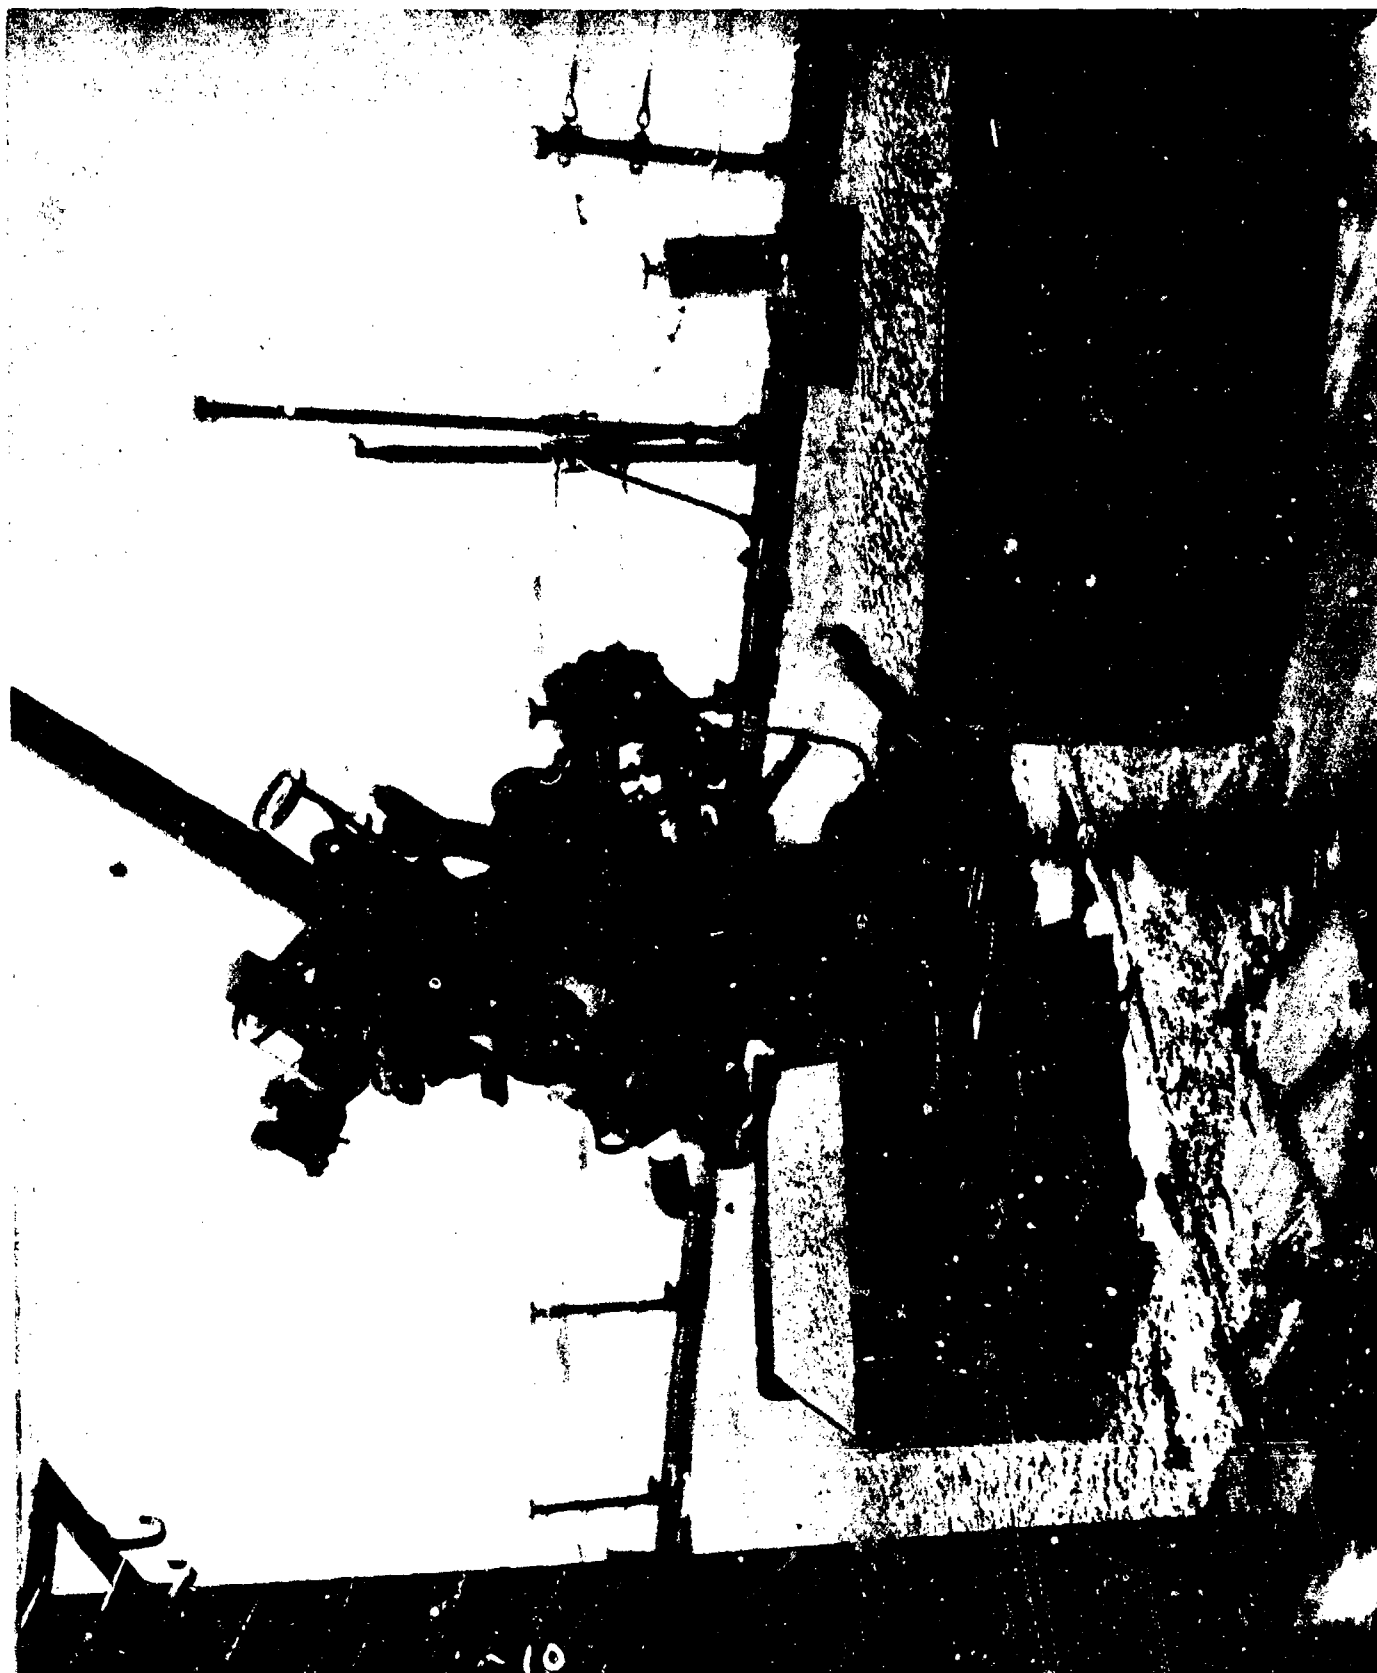
The principal cause of damage is underwater shock. The airplanes, ready service boxes and air intake louvres may have suffered damage from solid water taken aboard.

AB-CR-87-2544-10. Dislodged ready service boxes, main deck, starboard side about frame 100.

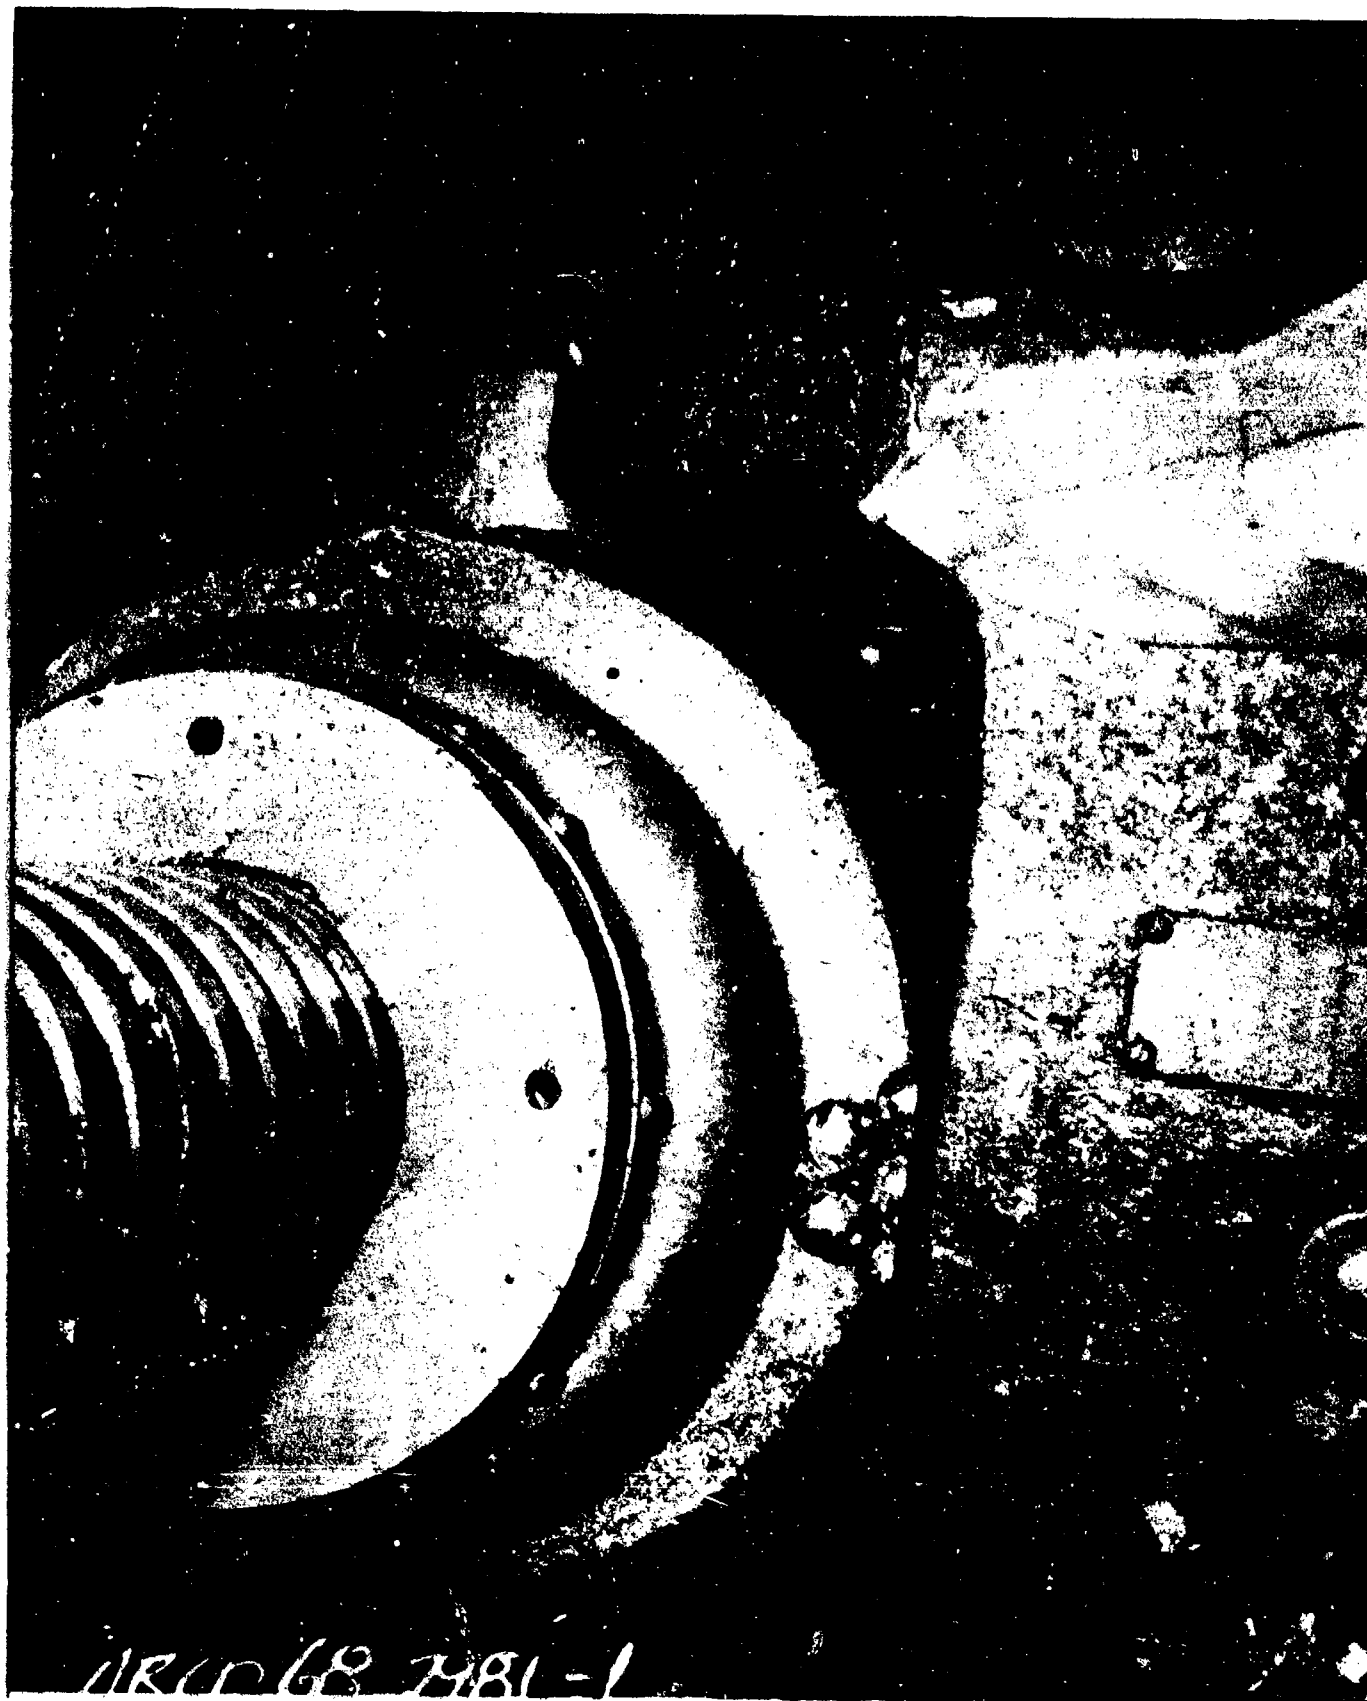
AB-CR-68-2981-1. Right gun of Turret 3, elevating screw oscillating bearing, looking down and to front showing top assembly pulled out of position and ball bearings scattered.

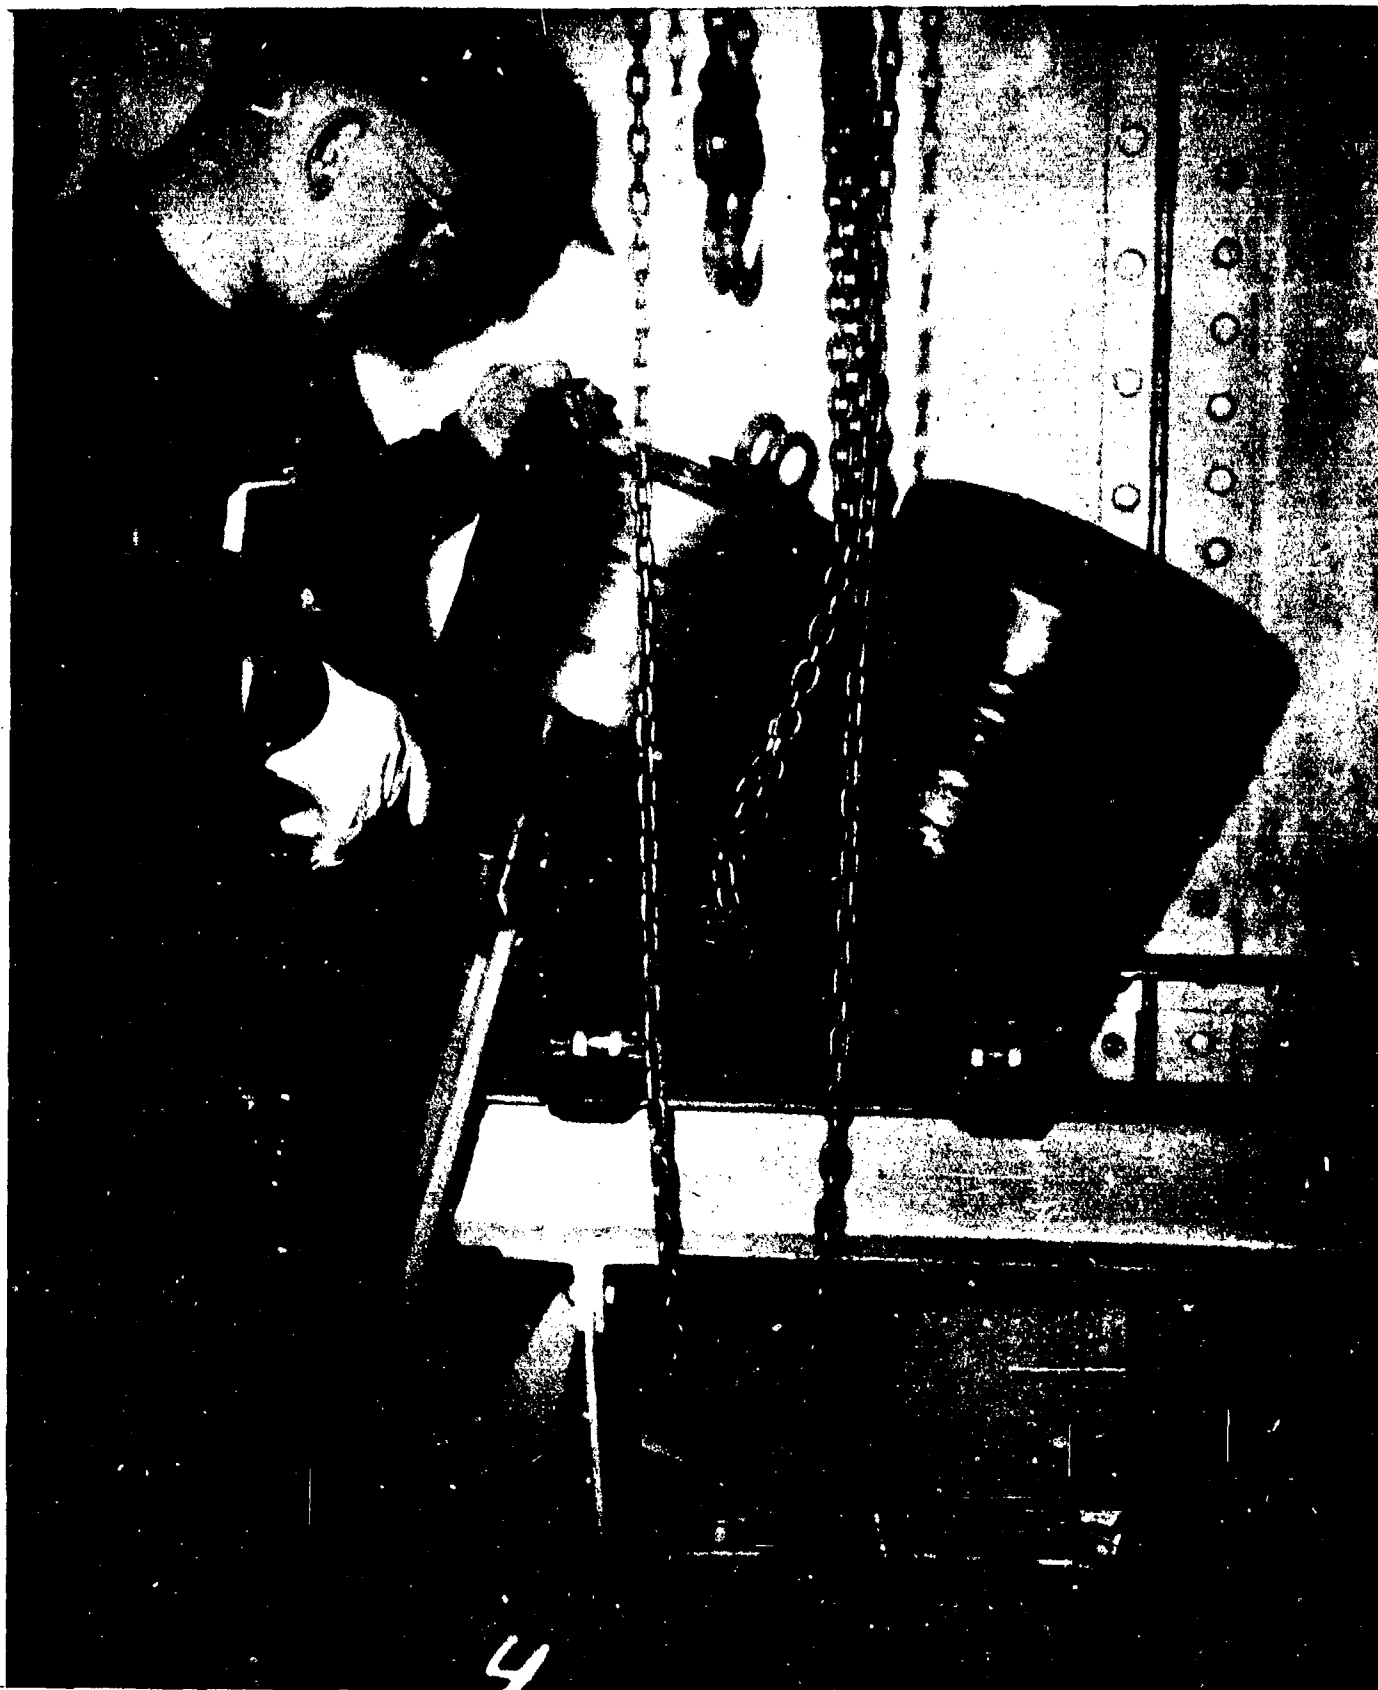
AB-CR-62-4164-4. Turret 5, projectile transfer level, left side, showing disarrangement of projectiles.

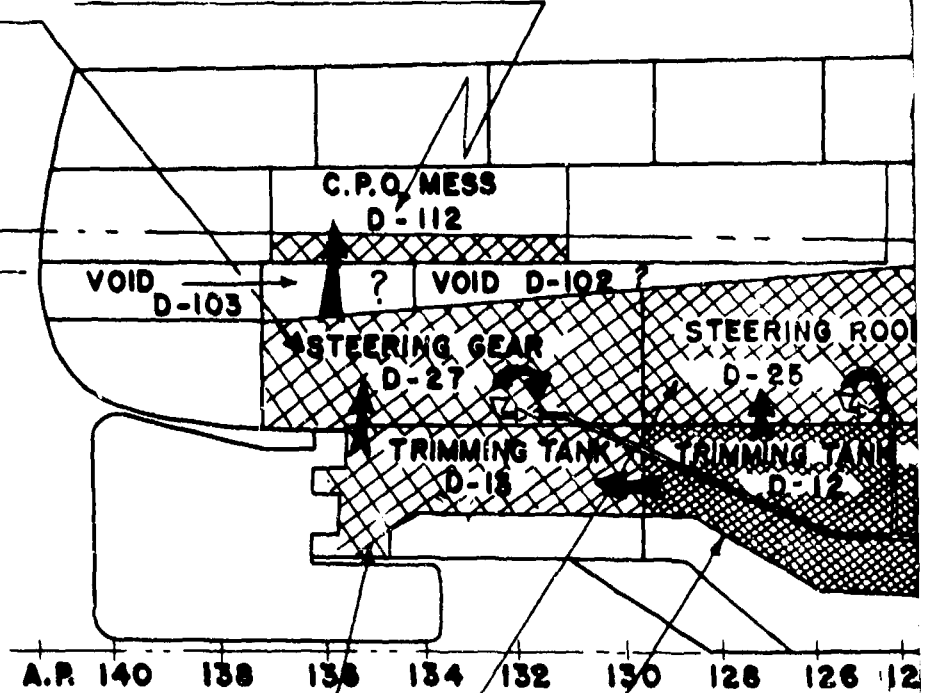
C.P.O MESS PARTIALLY FLOODED
POSSIBLY THROUGH BOLTED
RUDDER ACCESS PLATES

TRIMMING TANK D-13
FLOODED THRU RUDDER
POST AND FROM D-12

GRAVITY DRAIN LINE
IS PROBABLY BROKEN
IN D-12

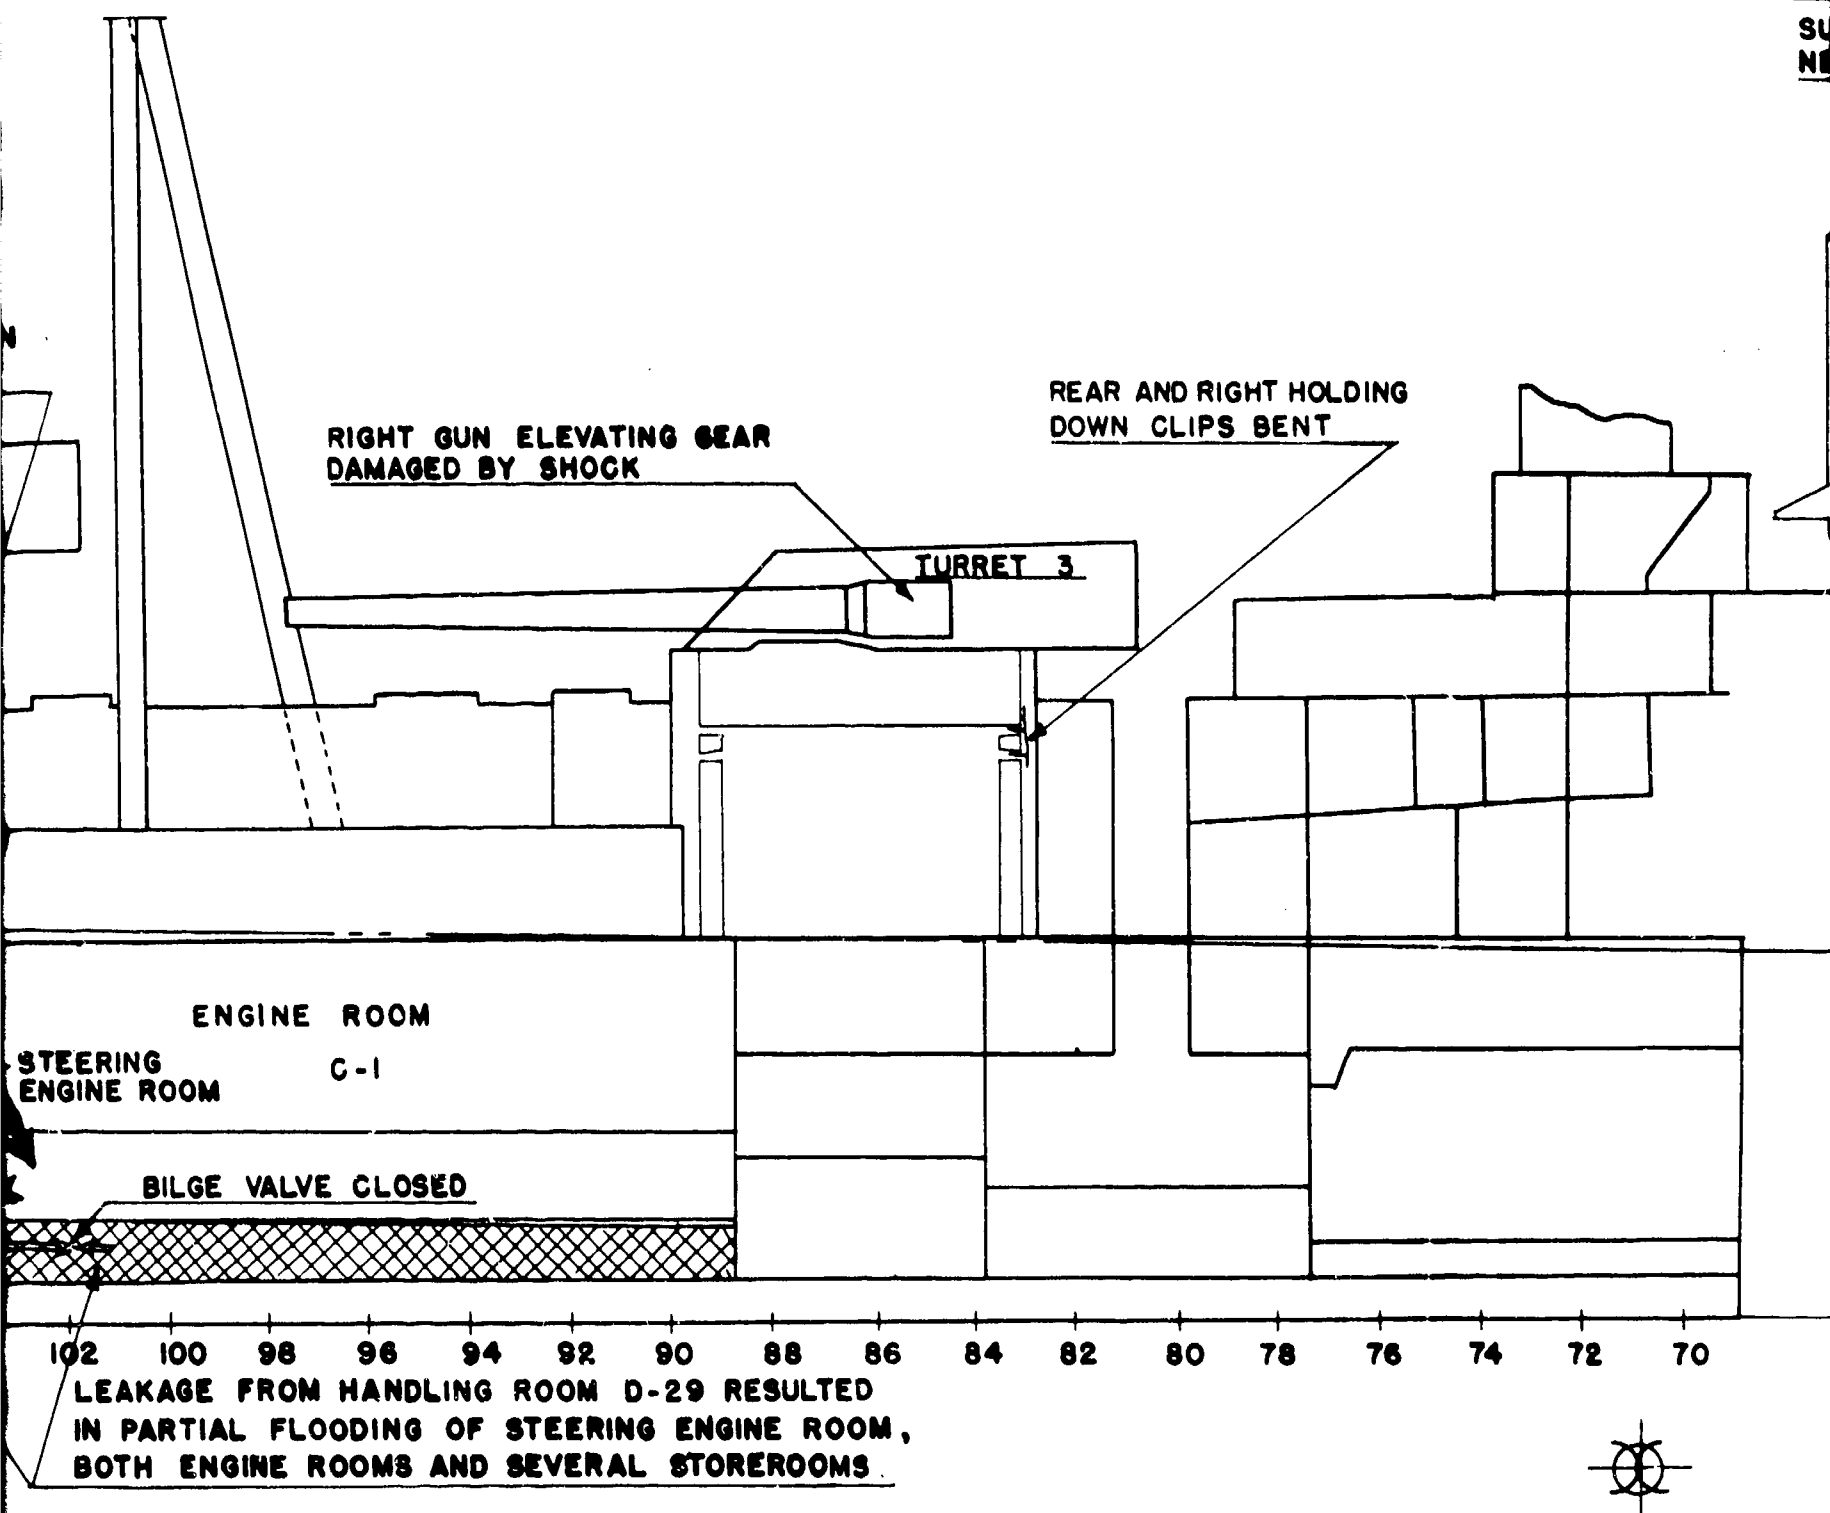
HANDLING ROOMS AND MAGAZINES ON
FIRST PLATFORM LEVEL FLOODED FOUR
FEET DEEP THRU DRAIN LINE AND LEAKY
BULKHEADS
